Manhole Inspection Summary

Manhole # S21E__058MH

Insp Date: **10/15/07 2:12 PM**

Location Address: **1900 ALLEY MULBERRY-SARATOGA** Cross Street: **MONROE ST**

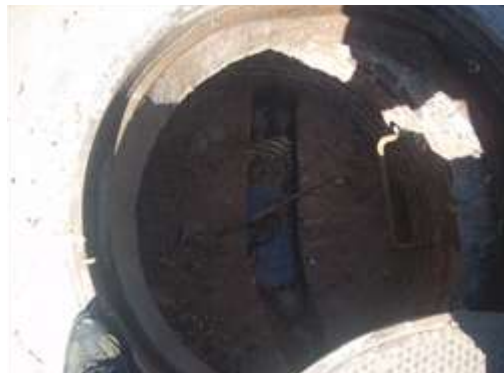
Top View

DEBRIS IN BECNH AND ON CHANNEL

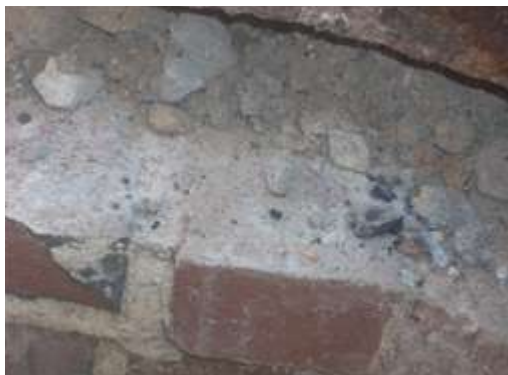
Defect 3

Chimney / Frame Adjustment ☒ Exists Material: **Concrete and Stone** ☐ Parged Height: **3** (in.)
Condition: ☐ Sound ☐ Cracked ☐ Root Intrusion ☐ Loose Brick ☒ **Deteriorated**
Infiltration: ☒ None ☐ Joint ☐ Cracks ☐ Mortar ☐ Roots ☐ Wall

CHIMNEY DETERIORATION

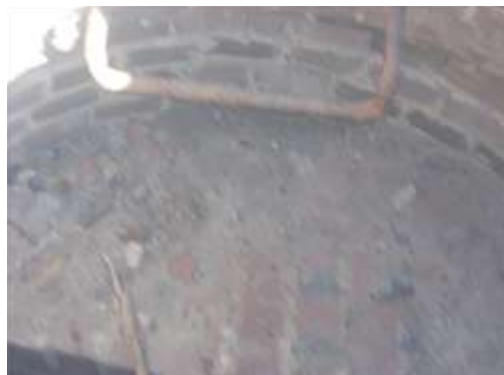
Defect 2

Steps Count: **1** Missing: **0** ☒ **Corroded**

CORRODED STEP

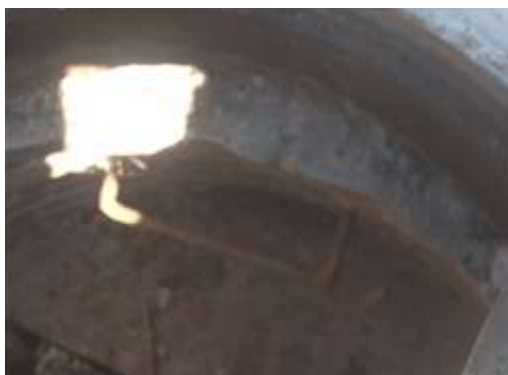
Defect 1

Frame Offset: **4** (in.) Condition: ☒ Sound ☐ Cracked ☐ Leaks

FRAME OFFSET

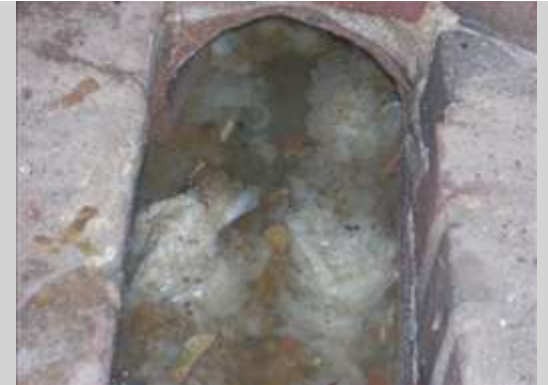
12 O'Clock Outflow

6 in. Circular Gravity Sewer
Pipe Out @ 12 O'Clock

Pipe Height: **6** (in.) Rod and Bar (Angled)
Pipe Material: **Clay** ☐ Pipe Lined
Invert Depth: **4.17** (ft.) Flow Characteristics: **Slow**
Deposits: ☐ None ☐ Mud ☒ Sludge ☒ Debris ☐ Grease
Silt Depth: **4** (in.) Deposits Extent: **Medium**
Infiltration: **None** Pipe Seal Cond: **Sound**

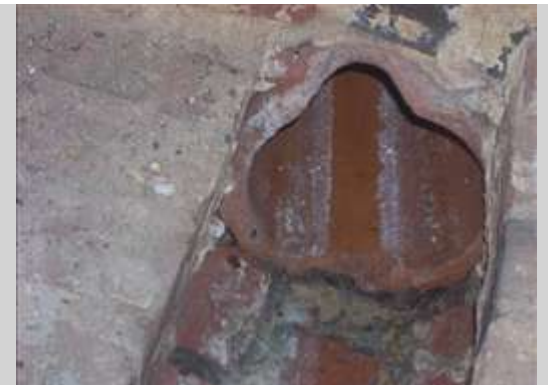
5 O'Clock Inflow

6 in. Circular Gravity Sewer
Pipe In @ 5 O'Clock

Pipe Height: **6** (in.) Rod and Bar (Angled)
Pipe Material: **Clay** ☐ Pipe Lined
Invert Depth: **3.99** (ft.) Flow Characteristics: **Slow**
Deposits: ☒ None ☐ Mud ☐ Sludge ☐ Debris ☐ Grease
Silt Depth: (in.) Deposits Extent:
Infiltration: **None** Pipe Seal Cond: **Broken**
